**Application of advanced laboratory experiments in  
understanding the cause of localized damage zones in Nuclear  
Waste Repository in Finland**

**F. Nasser, R.P.Young and L. Lombos  
University of Toronto, Department of Civil and Mineral Engineering.  
Rock Fracture Dynamic Group**

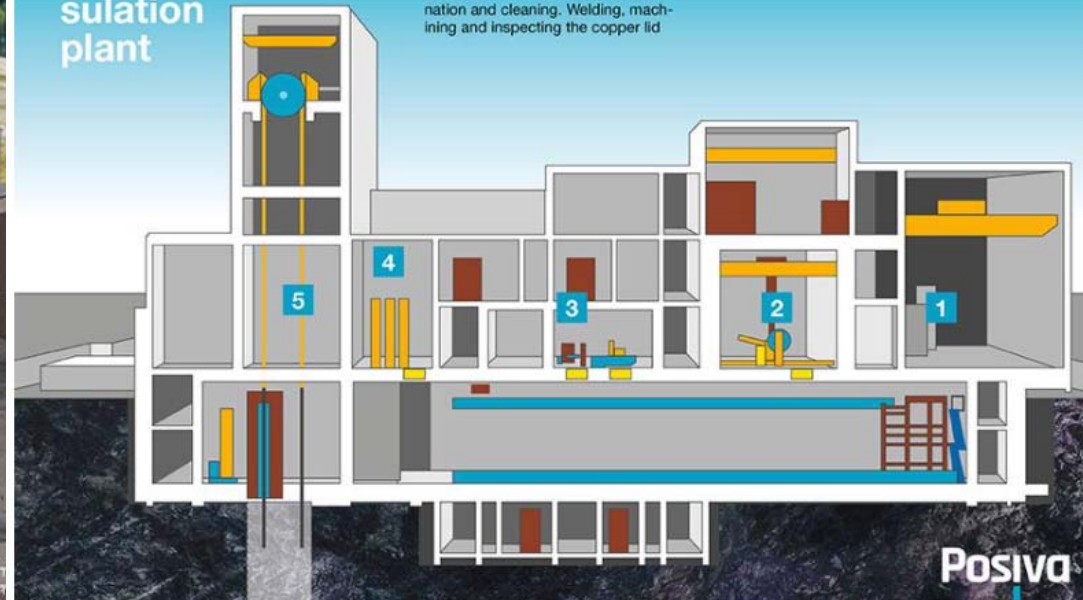
### Operation of the encap- sulation plant

1. Reception of fuel and storage of the transport cask
2. Hot cell (fuel handling chamber)
3. Measurement of surface contamination and cleaning. Welding, machining and inspecting the copper lid
4. Reception and storage of empty deposition canisters
5. Canister lift

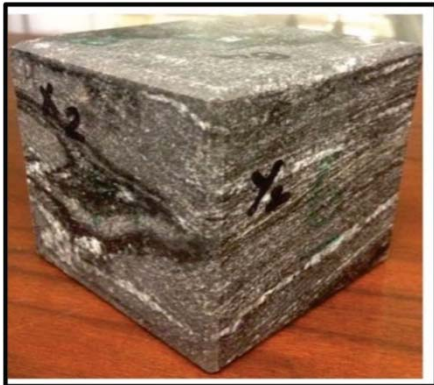
Tested specimen

- 90° gneissic specimen did not fail and looked intact after the test and showed little AE activity at the end of loading step 8.
- AE activity highlights the failure plane in the tested specimens 0°, 30° and 60°.
